TECHNICAL FEATURE

Testing for Leaks In Underfloor Plenums

By **Steven Anticknap, P.E.**, and **Mary Opalka**, Associate Member ASHRAE

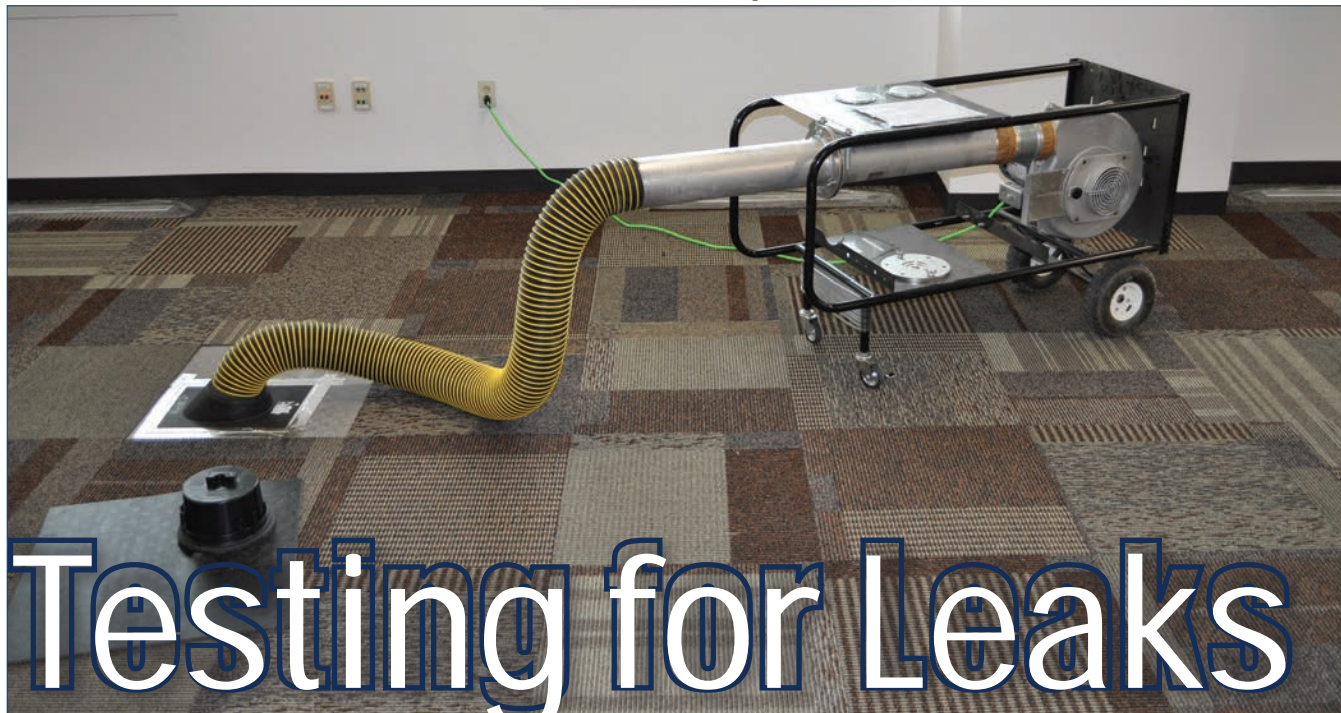
The test equipment used consisted of calibrated digital manometers with 0.0001 in. w.g. (0.025 Pa) resolution and data logging capability and adjustable orifice-type duct leakage fans. The fans had flex duct connected to their outlet. This flex duct was fed into the floor plenum through holes intended for the swirl diffusers. Foil-backed tape was used to secure the flex duct and seal the opening. The manometers were placed under the floor to monitor the underfloor pressure. This rig can be seen in the photo on the facing page.

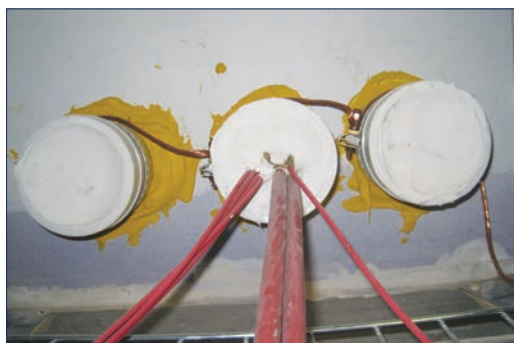
Power and telecom conduits had their ends sealed.

person was assigned to ensure that the plenums were being built to minimize leakage. This was done by ensuring that the bottom and edges of walls were sealed with plenum-rated caulking. Penetrations such as power and telecom conduits that entered the plenum boundaries had their below floor ends sealed, as shown at right. These qualitative visual inspections proved vital in maintaining positive testing results, especially since troubleshooting was complicated by USACE requirements forbidding the use of smoke to determine leakage points.

team that every penetration must be sealed and special attention must be paid to the conduits, which needed to be sealed on the edges and caulked on the sides.
